# Manhole Inspection Summary

Manhole # S31I\_\_025MH

Insp Date: **8/11/08 3:09 PM**

**Location** Address: **108 s paca st**

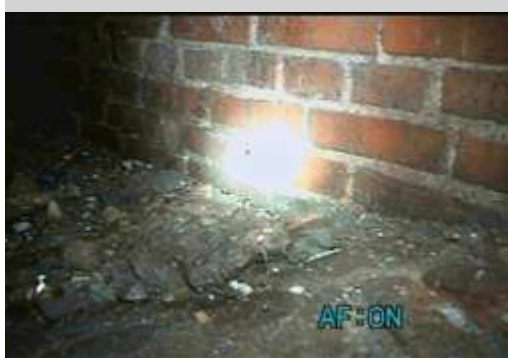
Misc

Condition: ☒ Sound ☐ Cracked ☐ Root Intrusion ☐ Deteriorated ☐ Leaks ☐ Debris

bench debris

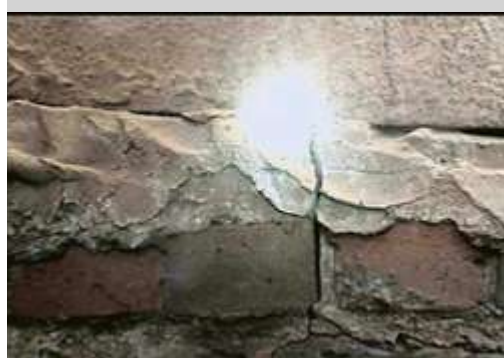
Defect 1

Condition: ☐ Sound ☒ **Cracked** ☐ Root Intrusion ☐ Loose Brick ☐ Deteriorated

chimney cond cracked

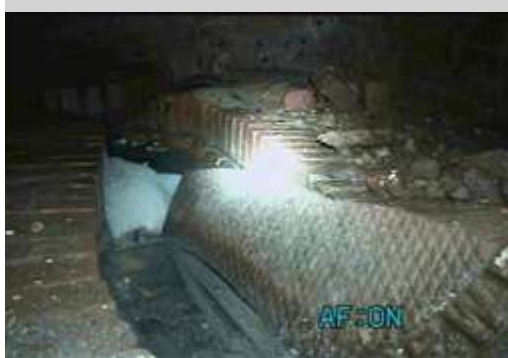
Defect 4

Condition: ☐ Sound ☐ Cracked ☐ Root Intrusion ☐ Deteriorated ☐ Leaks ☒ **Debris**

channel debris

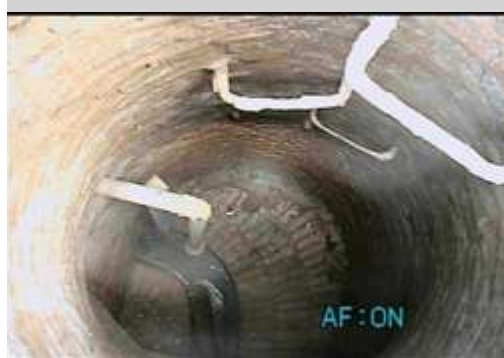
Defect 3

Count: **8** Missing: **5** ☒ **Corroded**

steps

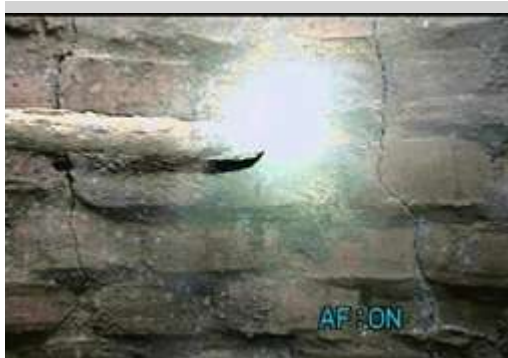
### Defect 2

Condition: ☐ Sound ☒ **Cracked** ☐ Root Intrusion ☐ Loose Brick ☐ Deteriorated

cracked corbel

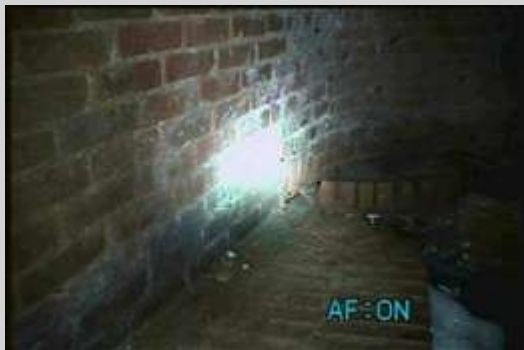
12 O'Clock Outflow

8 in. Circular Gravity Sewer  
Pipe Out @ 12 O'Clock

cant get better pic way under shelf

Invert Depth: **12.00** (ft.) Flow Characteristics: **Slow**

Infiltration: **None** Pipe Seal Cond: **Unknown**

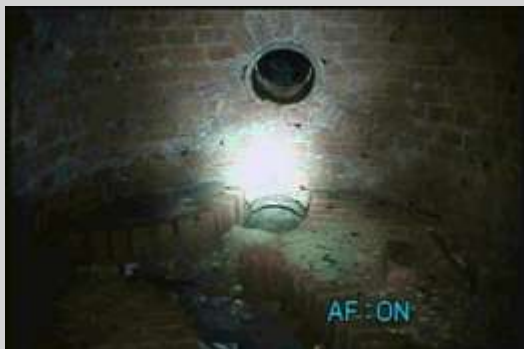
3 O'Clock Inflow

8 in. Circular Gravity Sewer  
Pipe In @ 3 O'Clock

under shelf cant get better pic

Invert Depth: **7.66** (ft.) Flow Characteristics: **Slow**

Infiltration: **None** Pipe Seal Cond: **Unknown**

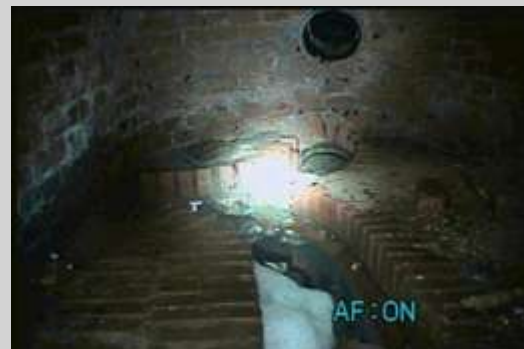
Drop In @ 3 O'Clock

Drop: **Inside** **Direct**

Inv Depth: **11.92** (ft.)

Drop Condition: **Open**

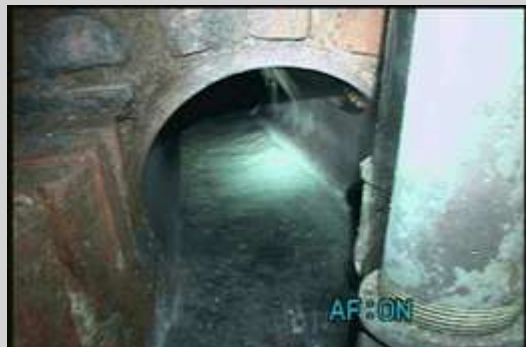
6 O'Clock Inflow

10 in. Circular Gravity Sewer  
Pipe In @ 6 O'Clock

Invert Depth: **11.96** (ft.) Flow Characteristics: **Slow**

Infiltration: **None** Pipe Seal Cond: **Unknown**
